**Report No. CG-D-09-99, III**

**United States Coast Guard  
Integrated Risk Assessment Process**

**Volume III**

**(Detailed Hazard Analysis of WMEC-270 Small Boat  
Operations, Detailed Hazard Analysis of WLIC-160  
Deck Operations, and Risk-based Safety Survey of  
a WHEC-378 Vessel)**

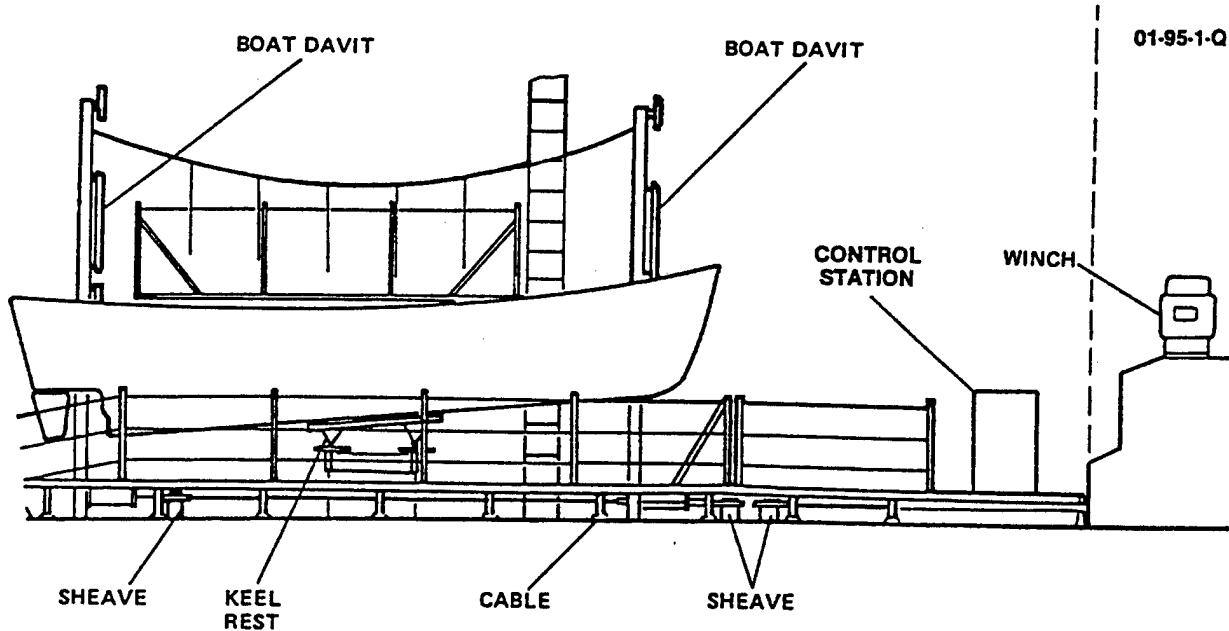
Figure D.1 MSB and Davit System (Side View)

**Hardware:** The MSB is controlled by a twin arm davit (boom) that moves inboard and outboard hydraulically. When cradled (stowed position), the MSB is held in place by two shoes (braces, one forward and one aft) and by a gripping strap that runs over the hull of the MSB, top to bottom, and attaches underneath the MSB. Two steel pins (one forward and one aft) lock the davit arms in place to prevent outward movement. Some COs prefer to operate at times with the davit arms partially extended so that the MSB is ready for loading and launching. However, this practice has two disadvantages: (1) even though a hydraulic lock on the davit may initially hold the MSB in place and ready for launch, the arms may extend (creep) outward after a few hours due to "leak by" on the hydraulic piston rams (from the weight of the MSB), which sets the MSB away from the launch deck; and (2) when extended, the chrome plating on the arms of the piston rams are exposed to a salt air environment, which accelerates corrosion. Figure D.1 and Figure D.2 show different views of the MSB davit/winch system.

An electric winch raises and lowers the MSB. The winch drives two fall lines (cables) that run through each davit arm and attach by blocks fore and aft on the MSB. Separate lines, known as frapping lines, are also attached to the fall lines and are handled by frapping line tenders (deck crewman) to reduce sway while raising and lowering the MSB. While raising or lowering, boat crew members hold onto support lines, known as monkey lines, that attach to a cable that runs between the davit arms. The monkey lines not only give boat crew members support while raising or lowering the MSB, but also act as life lines if the MSB accidentally drops into the water (e.g., if one or both fall lines break).

***Recommendation 9 — Consider installing a lip on the side of the vessel at the MSB boat deck to ensure that the MSB does not lose its grip while snugged to the hull when loading/unloading the boat crew and passengers.*** When placing the MSB against the hull (snugging it to the hull) in preparation for loading/unloading, the Deck Supervisor orders a slight inboard canter on the MSB to facilitate loading/unloading. In this position, the MSB rests on the rubber coating

***Recommendation 11 — Consider upgrading the MSB recovery procedure to include setting the davit arm pins back in place.*** Although this action is done when securing the MSB davit arms, it is not in the deck procedure. If it is overlooked, the unsecured davit arms may move while underway and damage the MSB. Adding this step to the procedure enhances its effectiveness as a training tool.

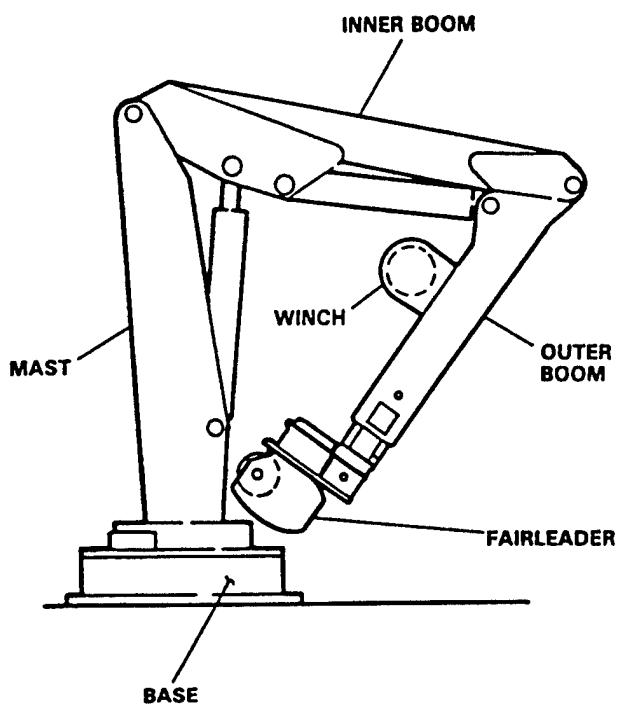
Figure D.3 RHI Articulating Crane

**Hydraulics:** The articulating crane has its own hydraulics systems located in the engine room. A single pump drives the system. A manually operated backup pump is included in the system and can be operated by deck personnel in an emergency. If hydraulic pressure is lost during operations due to a hose rupture, the boom is expected to move slowly downward, and the RHI would not drop very far to either the deck or the water.

**Location:** On WMEC-270 class vessels, the RHI articulating crane is located on the port side of the fantail. The control station is located just forward of it.

***Recommendation 12 — Consider extending the length of the port bridge wing to allow an increased view of RHI operations.*** Under the existing layout, the OOD, who is controlling the RHI launch/recovery operation from the bridge, cannot see the RHI or the deck crew's actions while the RHI is positioned over the fantail (the OOD can see the RHI when it is over or in the water). Without this view, the OOD has limited opportunities to correct or warn the deck crew of potentially dangerous situations that the Safety Supervisor or Deck Supervisor may not notice. Extending the port bridge wing out should provide the OOD an expanded view of RHI operations and allow an extra set of eyes to monitor evolution safety. There are, however, practical limits to how far the wing can be extended.

***Recommendation 13 — Consider adding a step to the RHI launch procedure that directs the boom cable to be hooked to the metal ring attached to the supporting straps.*** Although this action is done when launching the RHI, it is not in the deck procedure. Adding this step to the procedure enhances its effectiveness as a training tool.
